Manhole Inspection Summary

Manhole # S130__014MH

Location Address: **424 HURLEY AV**

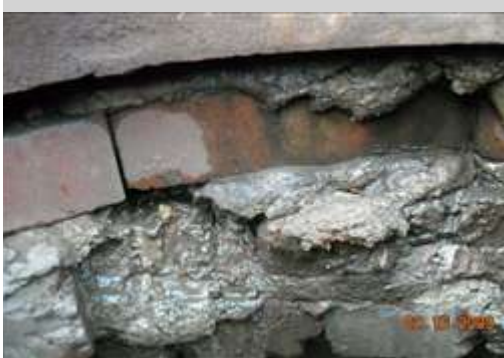
Misc

Additional view of chimney

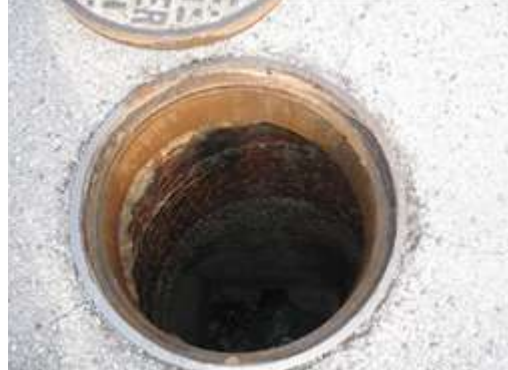
Misc

Frame Offset: **0** (in.) Condition: ☒ Sound ☐ Cracked ☐ Leaks

Frame View

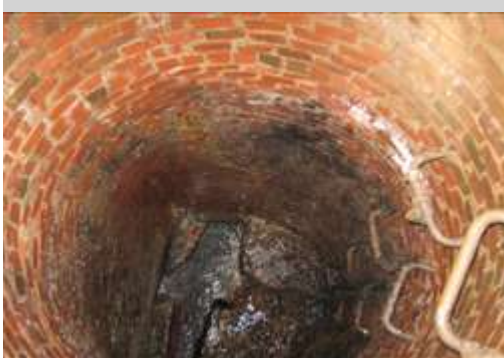
Defect 3

Steps Count: **8** Missing: **0** ☒ **Corroded**

Corroded Steps

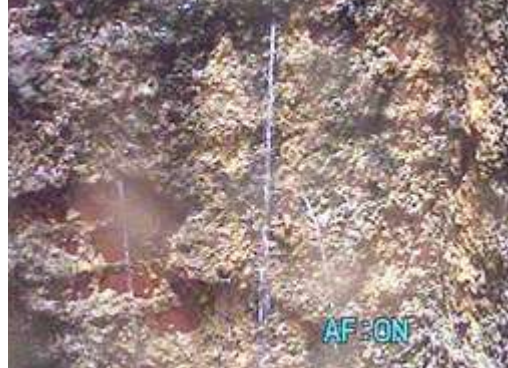
Defect 4

Infiltration: ☐ None ☐ Joint ☐ Cracks ☐ Mortar ☐ Roots ☒ **Wall**

active barrel infiltration

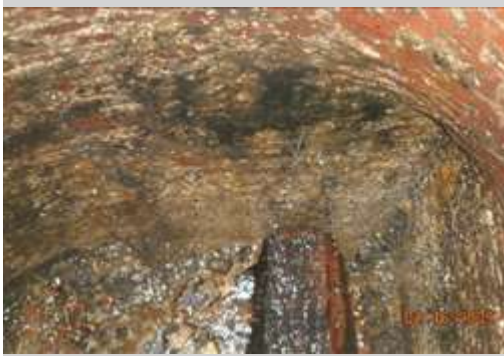
Defect 1

Infiltration: ☐ None ☒ **Joint** ☐ Cracks ☐ Mortar ☐ Roots ☒ **Wall**

infiltration in corbel

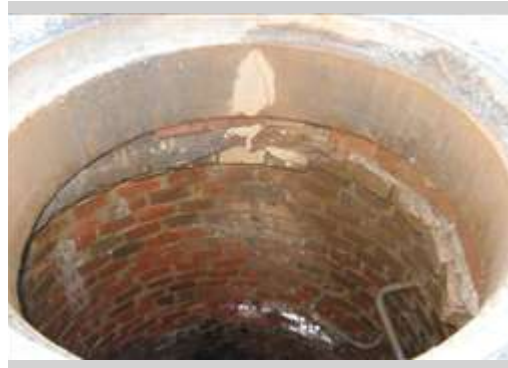
Defect 2

Condition: ☐ Sound ☐ Cracked ☐ Root Intrusion ☐ Loose Brick ☒ **Deteriorated**

Infiltration: ☐ None ☒ **Joint** ☐ Cracks ☐ Mortar ☐ Roots ☐ Wall

deteriorated chimney, infiltration @ chimney joint

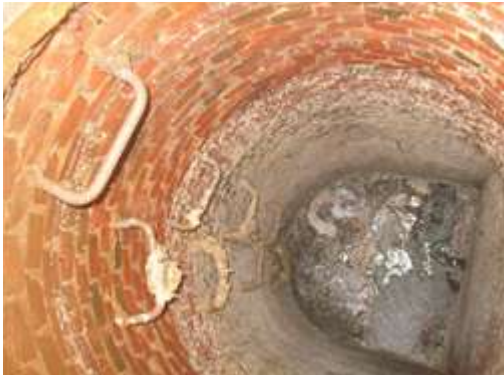
Defect 5

Condition: ☐ Sound ☐ Cracked ☐ Root Intrusion ☐ Deteriorated ☐ Leaks ☒ **Debris**

Surcharge ☒ **Evidence Of Surcharge** Depth: **6** (ft.) ☐ Active Surcharge Present

signs of surcharge, bench and channel debris prior to cleaning

Comments **HEAVY CLEANING FROM DOWNSTREAM MANHOLE S130__016MH TO REMOVE GREASE AND LOWER WATER LEVEL**

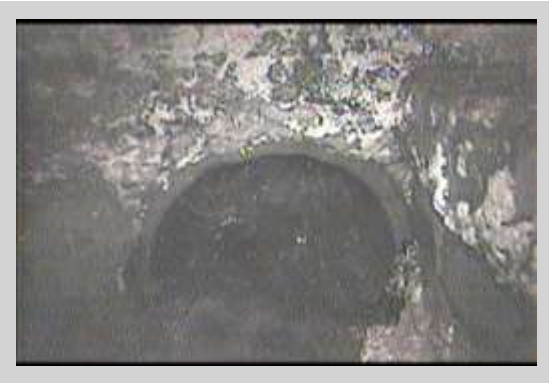
12 O'Clock Outflow

Pipe Height: **8.4** (in.) Rod and Bar (Angled)
Pipe Material: **Clay** ☐ Pipe Lined
Invert Depth: **14.64** (ft.) Flow Characteristics: **Fast**
Deposits: ☐ None ☐ Mud ☐ Sludge ☐ Debris ☒ Grease
Silt Depth: **1** (in.) Deposits Extent: **Light**
Infiltration: **None** Pipe Seal Cond: **Unknown**

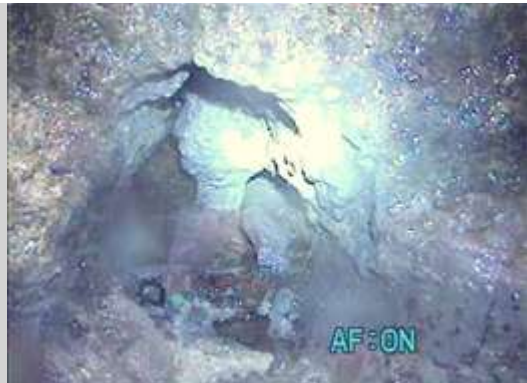
9 O'Clock Inflow

abandoned
